# Air Transportation Safety Investigation Report A1800153

## COLLISION WITH TERRAIN

Piper PA-28R-200, C-GDUM  
Brantford Airport, Ontario  
13 November 2018

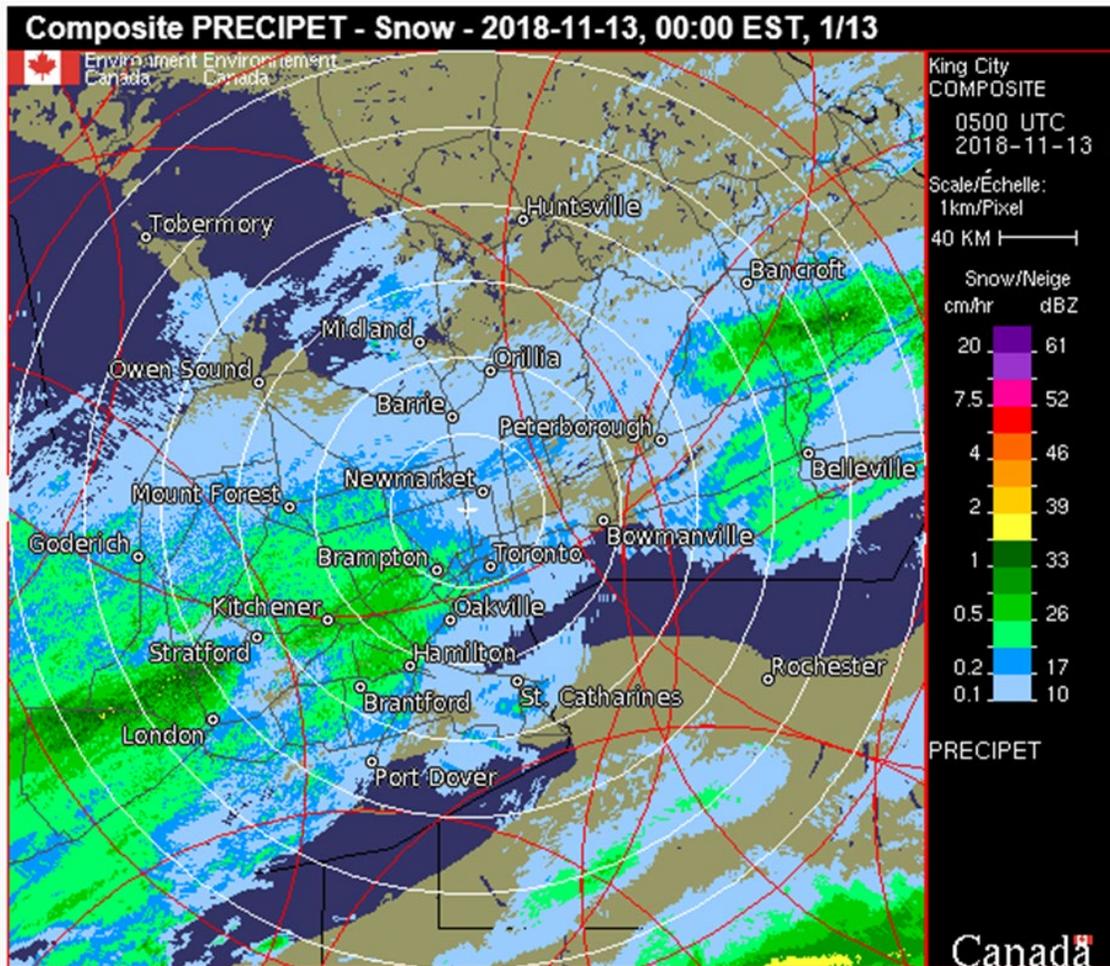
Based on historical weather radar data (Figure 1), there was precipitation in the form of rain or light snow at CZBA at the time of departure. The aerodrome routine meteorological reports from the 3 closest stations indicated visibilities as low as 1 statute mile in snow showers, and cloud ceilings at 1900 feet, with light winds and outside temperatures of around 0 °C at the surface.

Precipitation in the form of rain and/or snow was also recorded west of CZBA, and reduced visibility was reported for the entire route from CZBA to CYFD. With the freezing level at the surface, in-flight icing conditions were prevalent within this area of precipitation and within the clouds in this area.

Figure 1. Weather radar image showing system covering southeastern Ontario around the time of departure from CZBA (Source: Environment and Climate Change Canada)
