# Air Transportation Safety Investigation Report A1900026

## **COLLISION WITH TERRAIN**

Robinson Helicopter Company R66 (helicopter), C-GAUA  
Timmins (Victor M. Power) Airport, Ontario, 18 nm WNW  
04 March 2019

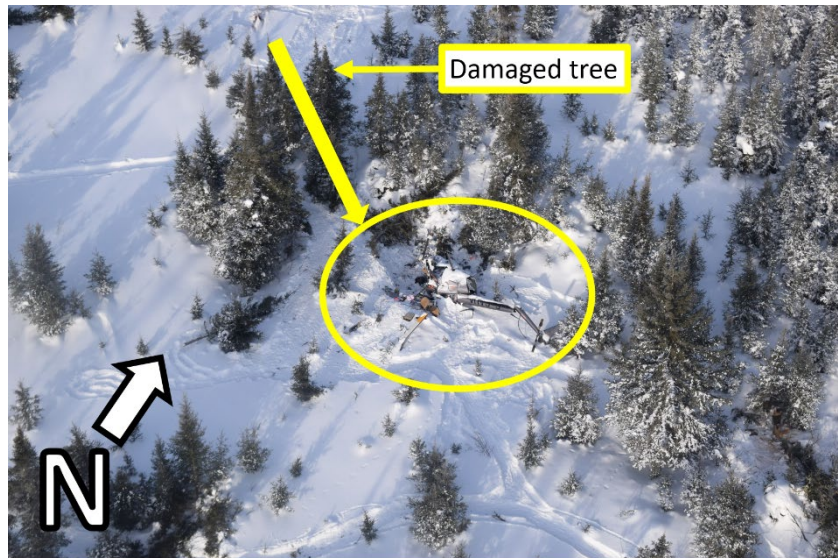
There was tree damage at the top of a coniferous tree located approximately 10 m (33 feet) west-northwest of the impact site (Figure 2). The tree damage and the damage to the helicopter indicated that the aircraft was in a steep nose-down, left-bank attitude when it struck the ground, on an approximate heading of 120° magnetic.

The helicopter then pitched over and came to rest on its back. The tail boom had snapped at approximately the midpoint, and there was minor damage to the tail rotor. The main rotor blades were mostly buried in the snow, but showed significant damage when uncovered. All portions of the main rotor blades were still attached to the mast, which was partially separated from the helicopter. The gearbox and the engine (Rolls Royce RR-300) had broken free of their mounts. There was a strong odour of jet fuel at the site.

Figure 2. Accident site, with the aircraft wreckage circled and an arrow showing the direction of impact (Source: TSB)
