# Air Transportation Safety Investigation Report A1900026

## **COLLISION WITH TERRAIN**

Robinson Helicopter Company R66 (helicopter), C-GAUA  
Timmins (Victor M. Power) Airport, Ontario, 18 nm WNW  
04 March 2019

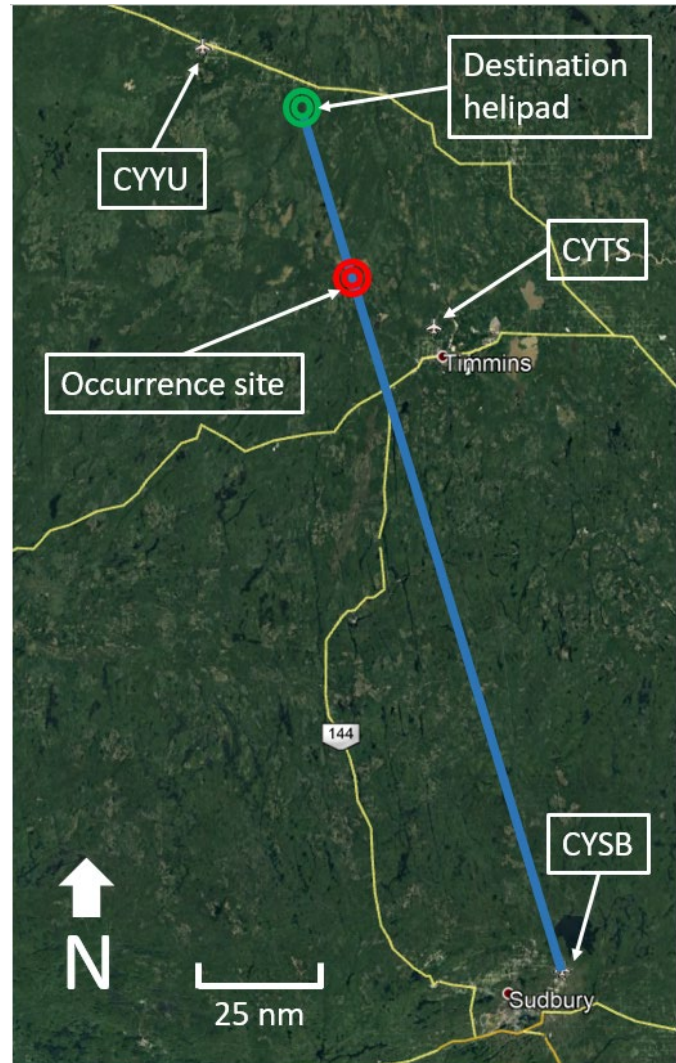
Figure 1. Route of the occurrence flight, showing the intended destination and the occurrence site (Source: Google Earth, with TSB annotations)
